Manhole Inspection Summary

Manhole # S53A__010MH

Insp Date: **5/6/08 2:11 PM**

Location Address: **3400 n highland ave**

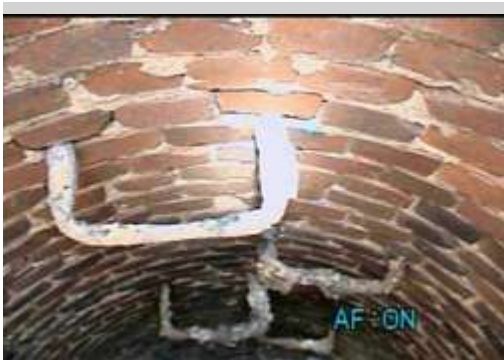
Defect 1

Condition: ☐ Sound ☐ Cracked ☐ Root Intrusion ☒ **Loose Brick** ☐ Deteriorated

Count: **5** Missing: **1** ☒ **Corroded**

corroded steps and loose bricks in chimney

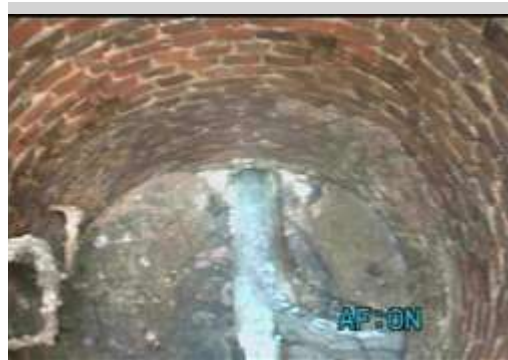
Defect 2

Condition: ☐ Sound ☐ Cracked ☐ Root Intrusion ☒ **Deteriorated** ☐ Leaks ☐ Debris

Bench condition deteriorated

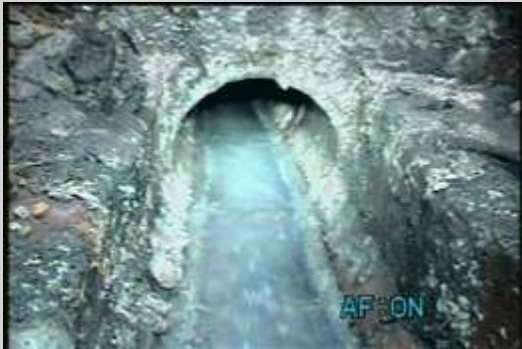
12 O'Clock Outflow

8 in. Circular Gravity Sewer
Pipe Out @ 12 O'Clock

Pipe Material: **Clay** ☐ Pipe Lined

Invert Depth: 11.00 (ft.) Flow Characteristics: **Fast**

Deposits: ☒ None ☐ Mud ☐ Sludge ☐ Debris ☐ Grease

Infiltration: **None** Pipe Seal Cond: **Unknown**

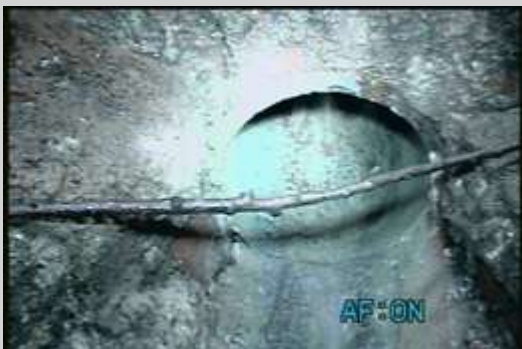
3 O'Clock Inflow

8 in. Circular Gravity Sewer
Pipe In @ 3 O'Clock

Pipe Material: **Clay** ☐ Pipe Lined

Invert Depth: 10.80 (ft.) Flow Characteristics: **Fast**

Deposits: ☒ None ☐ Mud ☐ Sludge ☐ Debris ☐ Grease

Infiltration: **None** Pipe Seal Cond: **Unknown**

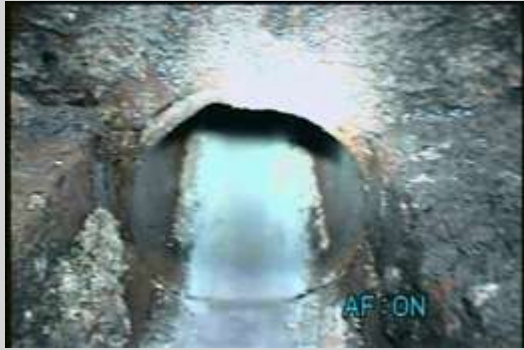
6 O'Clock Inflow

Pipe In @ 6 O'Clock

Pipe Material: **Clay** ☐ Pipe Lined

Invert Depth: **10.80** (ft.) Flow Characteristics: **Fast**

Deposits: ☒ None ☐ Mud ☐ Sludge ☐ Debris ☐ Grease

Infiltration: **None** Pipe Seal Cond: **Unknown**
